# PROPERTY INSPECTION REPORT

6/200 Papamoa Beach Road, Papamoa

23 September 2026

### **INSPECTION REPORT ADDRESS: 6/200 Papamoa Beach road, Papamoa**

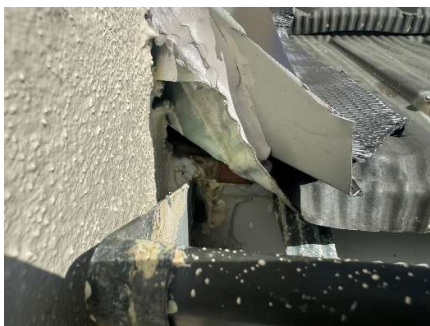
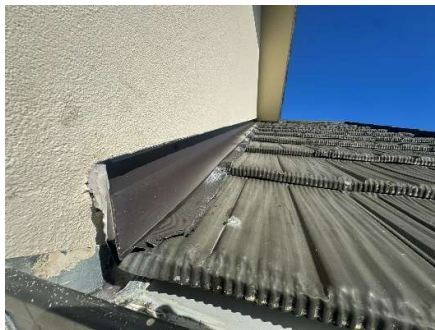
- **Type:** Textured Poly (EFIS)
- **Condition:** Average - Repairs and Maintenance required
- **Window Facings Condition:** Average - Repairs & Maintenance Required

- **Noted:** An opening into the roof space was observed at the termination of the roof-to-wall apron flashing at the entry door roof. The opening is located beneath the flashing and is relatively well protected from direct weather exposure. The adjacent gutter is also positioned away from the wall, and no evidence of moisture ingress was observed at the time of inspection.

- **Noted:** This type of exterior cladding is required to be painted every 8 to 10 years or earlier if the paint starts to oxidize. The paint finish is an integral part of the waterproofing system and should always be well maintained.

- **Recommendation:** Although the opening is considered unlikely to allow direct water entry under normal conditions, the detailing is unfinished. As part of future roof maintenance works, have the opening appropriately closed and the flashing termination tidied to provide a complete and durable finish.

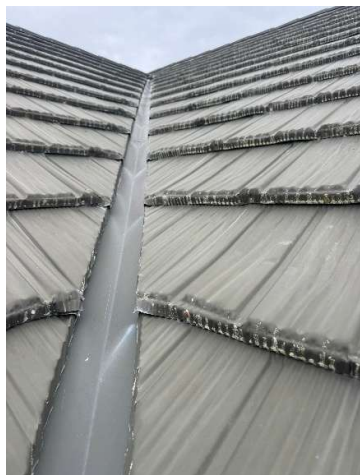
- **Type:** Pressed and Painted metal tiles
- **Condition:** Average - Repairs & Maintenance Required
- **Valleys:** Colorsteel
- **Noted:** Some lichen growth is beginning to develop on the roofing tiles.
- **Recommendation:** Clean and treat the roofing as required to remove lichen growth, prevent further build-up, and help maintain the serviceable life of the roofing tiles.
- **Noted:** There is some surface rust starting to appear on the roof fixings.
- **Recommendation:** Clean off and paint with rust retardant paint as required.

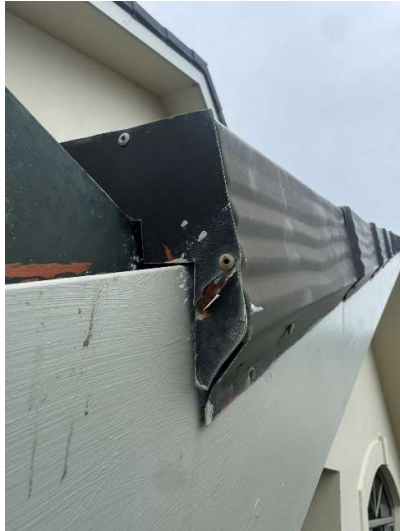
- **Type:** Metal
- **Condition:** *Average - Repairs & Maintenance Required*
- **Ridge & Hip Cap Condition:** *Average*
- **Noted:** There is some surface rust starting to appear on the roof fixings.
- **Noted:** There is rust appearing on some of the flashings and they are corroding.
- **Recommendation:** *Clean off and paint with rust retardant paint as required.*

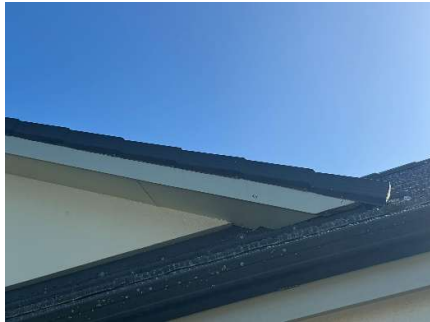
- **Type:** Timber
- **Condition:** *Average*
- **Noted:** This type of exterior fascia is required to be painted every 8 to 10 years or earlier if the paint starts to oxidize. The paint finish is an integral part of the waterproofing system and should always be well maintained.

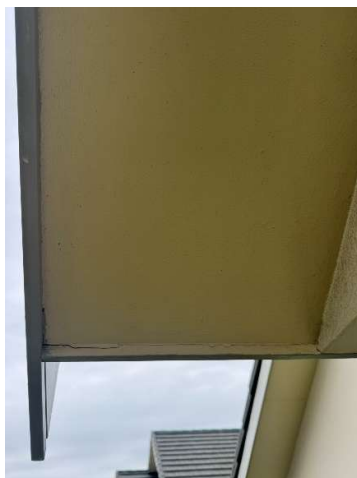
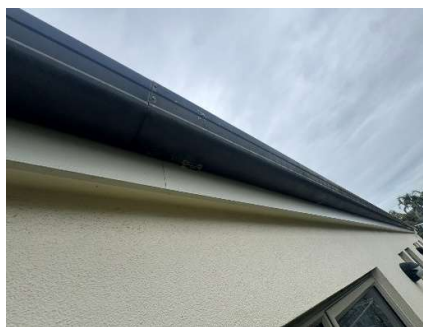
- **Type:** Flat Hardie sheets,
- **Condition:** *Average*
- **Noted:** The dwelling has small or minimal roof overhangs (soffits) in some places and does not adequately provide protection from the weather to door and window openings.
- **Recommendation:** *Regular painting and seal checks will be required.*

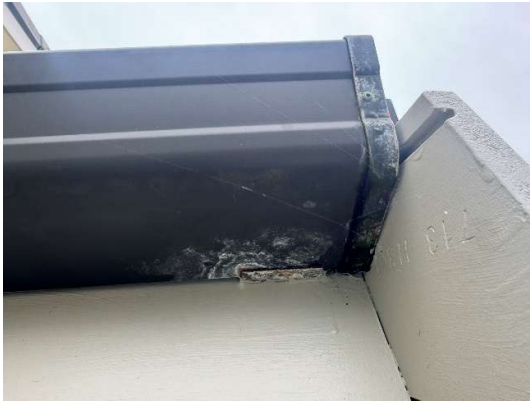
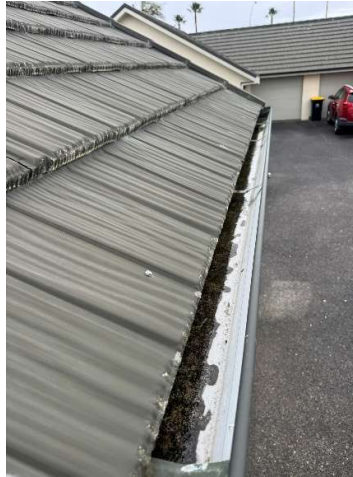
- **Type:** Colorsteel
- **Condition:** Average - Repairs & Maintenance Required
- **Noted:** Some organic matter and debris were observed within the spouting.
- **Recommendation:** Clean out the spouting and maintain regularly to ensure stormwater can drain freely and prevent blockages.
- **Noted:** Sections of the guttering and the adjacent gutter brackets are showing signs of corrosion.
- **Recommendation:** Clean and treat the affected areas with an appropriate rust-inhibiting coating and replace any significantly corroded sections or brackets as required.
- **General:** Guttering should have a minimum of 10 mm gap between the exterior cladding and the end of the guttering.

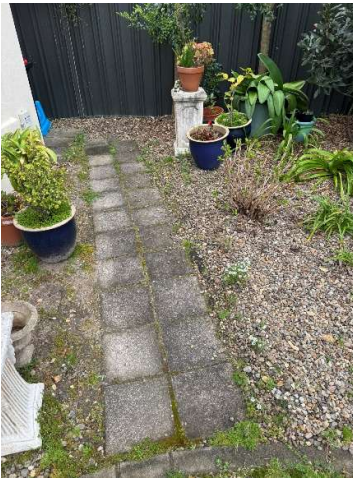
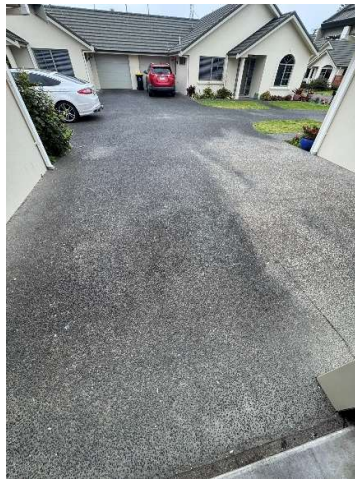
- **Type:** Concrete, Pavers
- **Condition:** *Average*
- **Noted:** Some undulation is evident to the pathway pavers, consistent with general age and settlement of the underlying ground.
- **Recommendation:** *Monitor and re-level the affected pavers as required, particularly where they may create a trip hazard or restrict surface water drainage.*

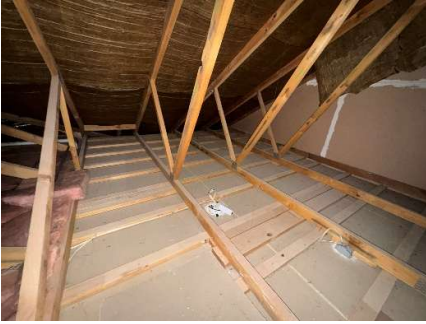
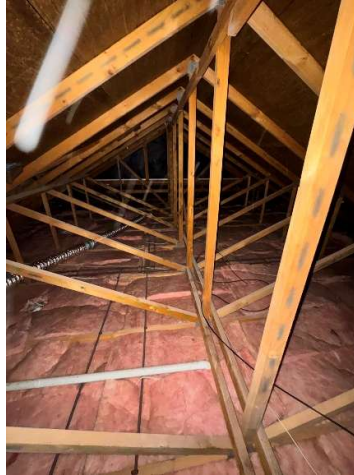
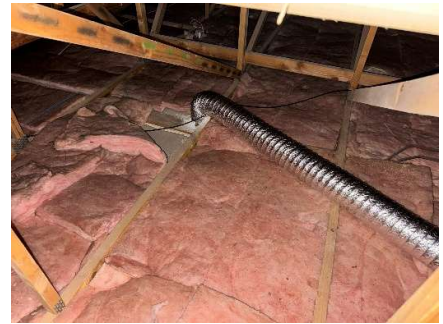
- **Type:** Pink Batts
- **Condition:** *Average – repairs and maintenance required*
- **Is Insulation clear of down lights:** Yes No
- **Noted:** Ceiling insulation has been displaced in places during the installation of services and has not been reinstated correctly.
- **Recommendation:** *Reposition and reinstate the insulation to provide continuous and even coverage throughout the affected areas.*
- **Noted:** The insulation may not be the recommended thickness for rental properties.
- **Garage:** Not Insulated

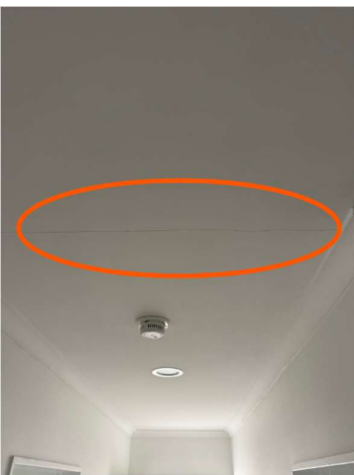
- **Type:** Gib Board,
- **Condition:** *Average - Repairs & Maintenance Required*
- **Noted:** A minor hairline crack is evident to the hallway ceiling lining, consistent with normal settlement and age of the dwelling.
- **Recommendation:** *Repair and redecorate as part of normal property maintenance as required.*
- **Textured:** No

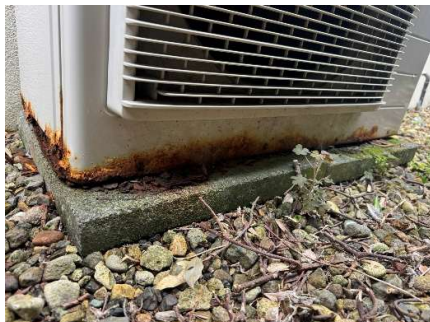
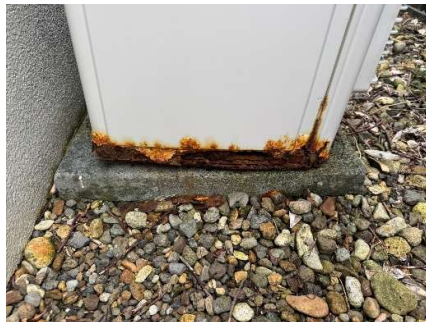
- **Type:** Air Conditioning Unit
- **Condition:** *Marginal - Repairs & Maintenance Required*
- **Noted:** Heavy corrosion is evident to the exterior air-conditioning unit.
- **Recommendation:** *Have the air-conditioning unit assessed by a suitably qualified technician and repair or replace the affected components/unit as required.*
- **Recommendation:** *Clean and service this unit prior to use. Failing to do so can affect insurance cover if heater is found to be the cause of the fire. Heater should be serviced by a qualified technician and client should be supplied with a service certificate.*

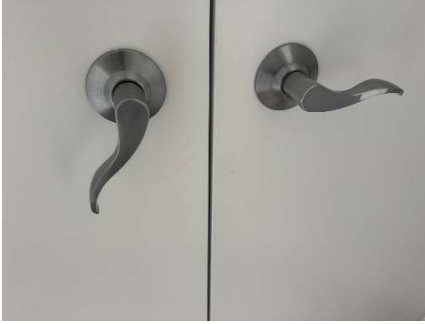
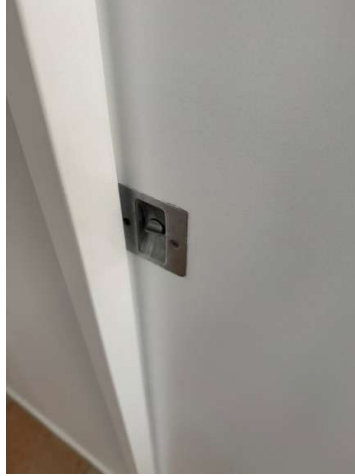
- **Type:** Lever type
- **Condition:** *Average - Repairs & Maintenance Required*
- **Noted:** Some internal doors do not latch correctly.
- **Recommendation:** *Adjust the affected doors and latch hardware as required to ensure correct operation.*
- **Noted:** The cavity sliding door latch is difficult to operate and latch correctly.
- **Recommendation:** *Adjust or repair the latch mechanism as required to ensure correct operation.*
- **Noted:** The springs within some door lever hardware are loose and no longer operating correctly.
- **Recommendation:** *Repair or replace the affected door lever hardware as required.*
- **Noted:** Some dummy door hardware is loose.
- **Recommendation:** *Tighten and secure the affected hardware as required.*
