# BUILDING INSPECTION REPORT

9 Sep 2026 / 17 Conie Glen Lane

## Pre-Purchase/Sale Visual Non-Invasive Property Inspection

Eye Spy Property Inspections  
Pre sale building report  
17 Conie Glen Lane, Broomfield

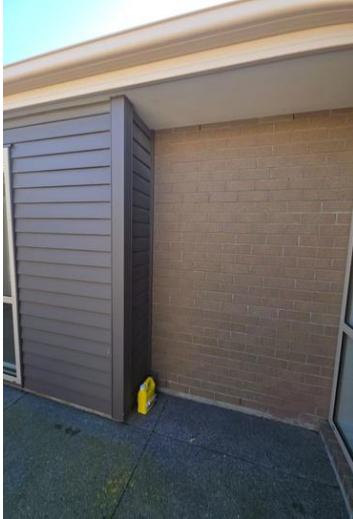
Photo 23

The solid brick veneer on a cavity system appears structurally sound, with no evidence of significant cracking or movement.

The painted linear weatherboard on a cavity system appears to be in a condition typical for its age.

One broken linear scribe has been identified; we recommend engaging a qualified tradesperson for further assessment and remediation.

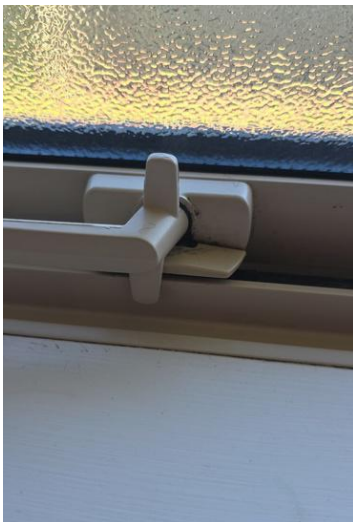
Photo 28

The property features aluminum double-glazed external joinery. Several window catches have damaged closing tabs, which may prevent the units from sealing securely. We recommend engaging a qualified professional to assess the issue and provide appropriate repair solutions.

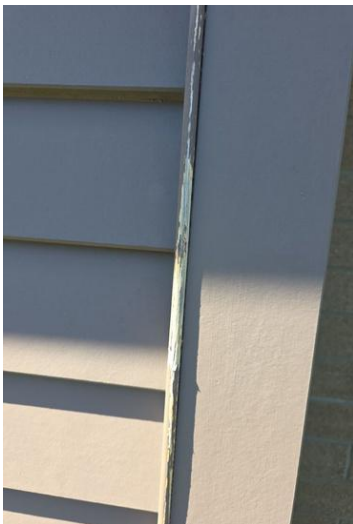
Photo 37

The condition is consistent with the age of the house.  
Routine maintenance, including repainting several timber linear scribes, is scheduled for the near future.

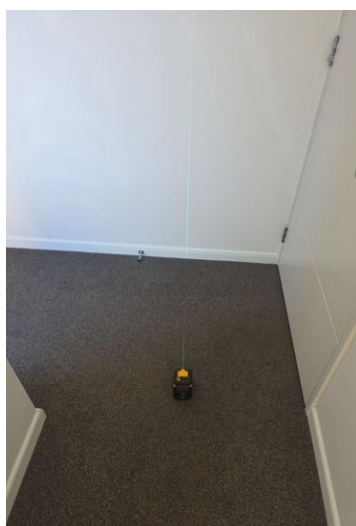
Photo 85

**The floor slope between two points greater than 2m apart is less than 0.5% (1:200) as per MBIE guidelines and/or any slope differential slightly outside mbie guidelines is deemed typical for age and style of house and does not require further investigation**

Well within guidelines

**The variation in level over the floor plan is less than 50mm over 10m as per MBIE guidelines.**

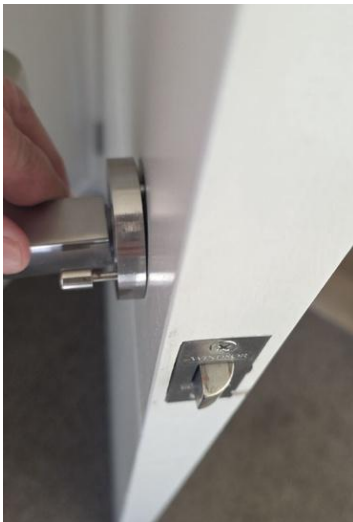
Photo 100

Internal door operational. Handle coming loose.  
Steel sectional door with automatic opener operational.  
Aluminium single glazed external joinery

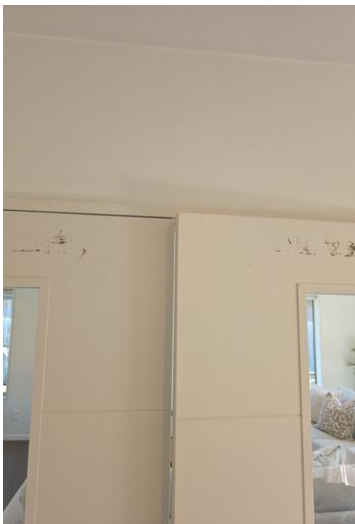
Photo 124

Interior doors are currently operational; however, the double doors require adjustment to ensure proper closure. Please recommend a qualified professional to assess the situation. The exterior joinery consists of aluminum double glazing.

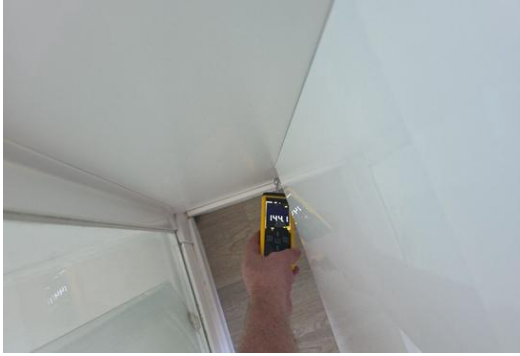
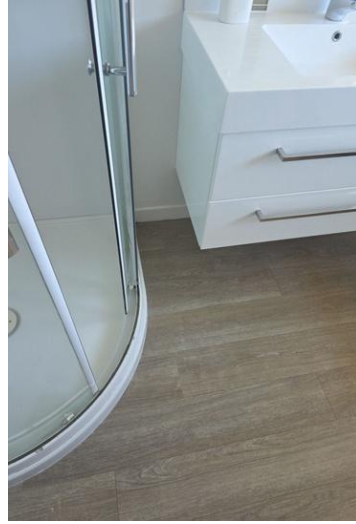
Elevated moisture levels have been detected at the base of the wall situated between the shower and vanity. We recommend engaging a qualified professional to assess the situation and provide appropriate remediation advice.
