# LAND INFORMATION MEMORANDUM

Property address:  
281A Innes Road

**Property address** 281A Innes Road, St Albans, Christchurch  
**Valuation roll number** 22291 01702  
**Valuation information** Capital Value: \$1,000,000  
Land Value: \$440,000  
Improvements Value: \$560,000  
*Please note: these values are intended for Rating purposes*  
**Legal description** Lot 4 DP 476751  
**Existing owner** Robert Lester Warner  
Lorraine Teresa Warner  
281A Innes Road  
Christchurch 8052

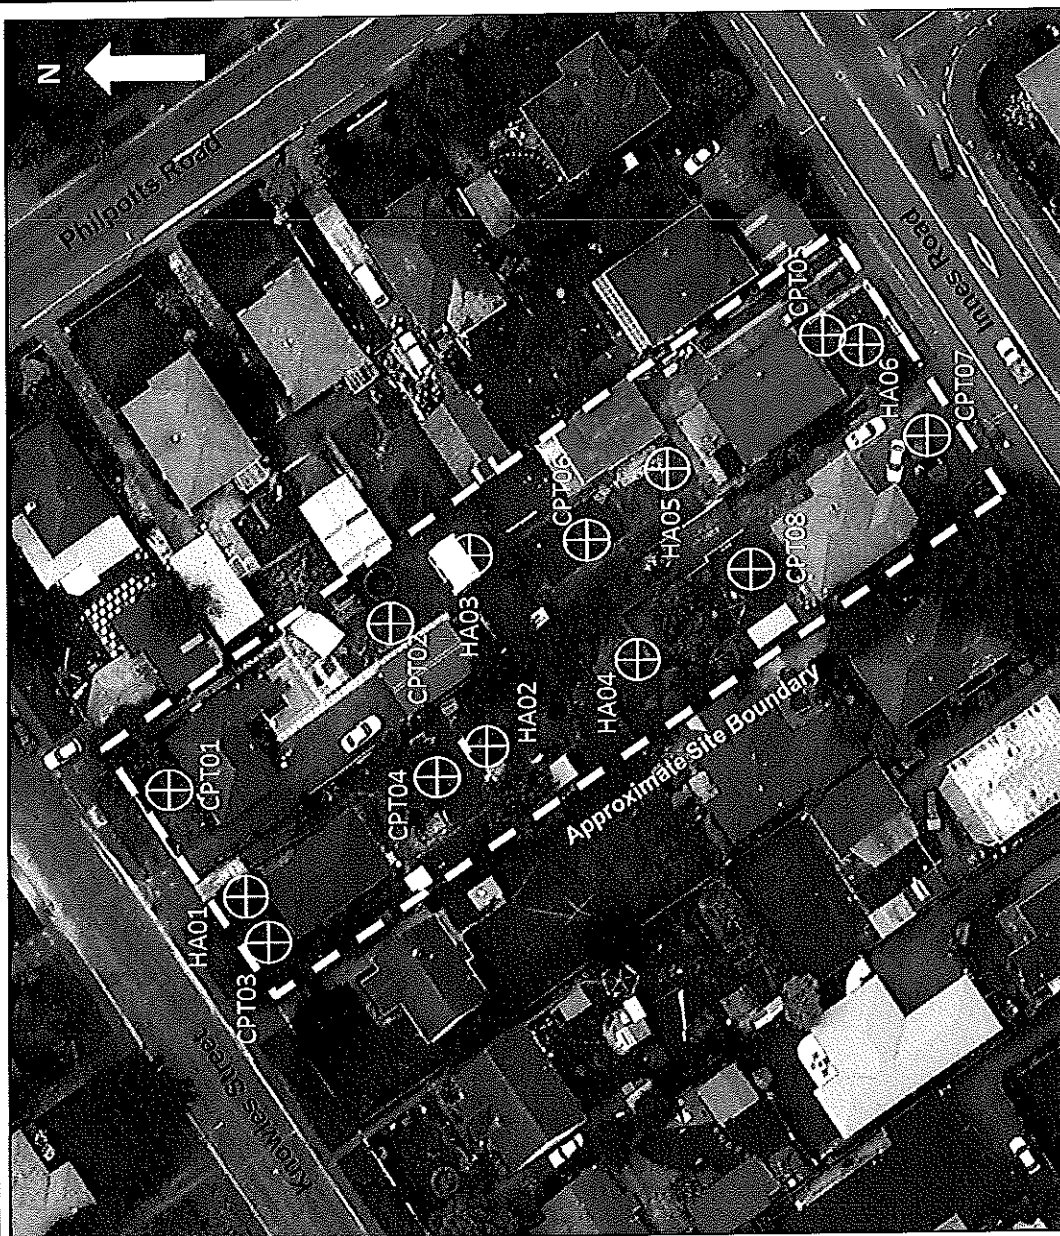
| Scale | NTS | Figure Number | 1 | Project Number | 11315_1 |

= Test Location

| Drawn by | TL | Project | 281 & 283 Innes Road and 272 & 274 Knowles Street, Mairehau, Christchurch |

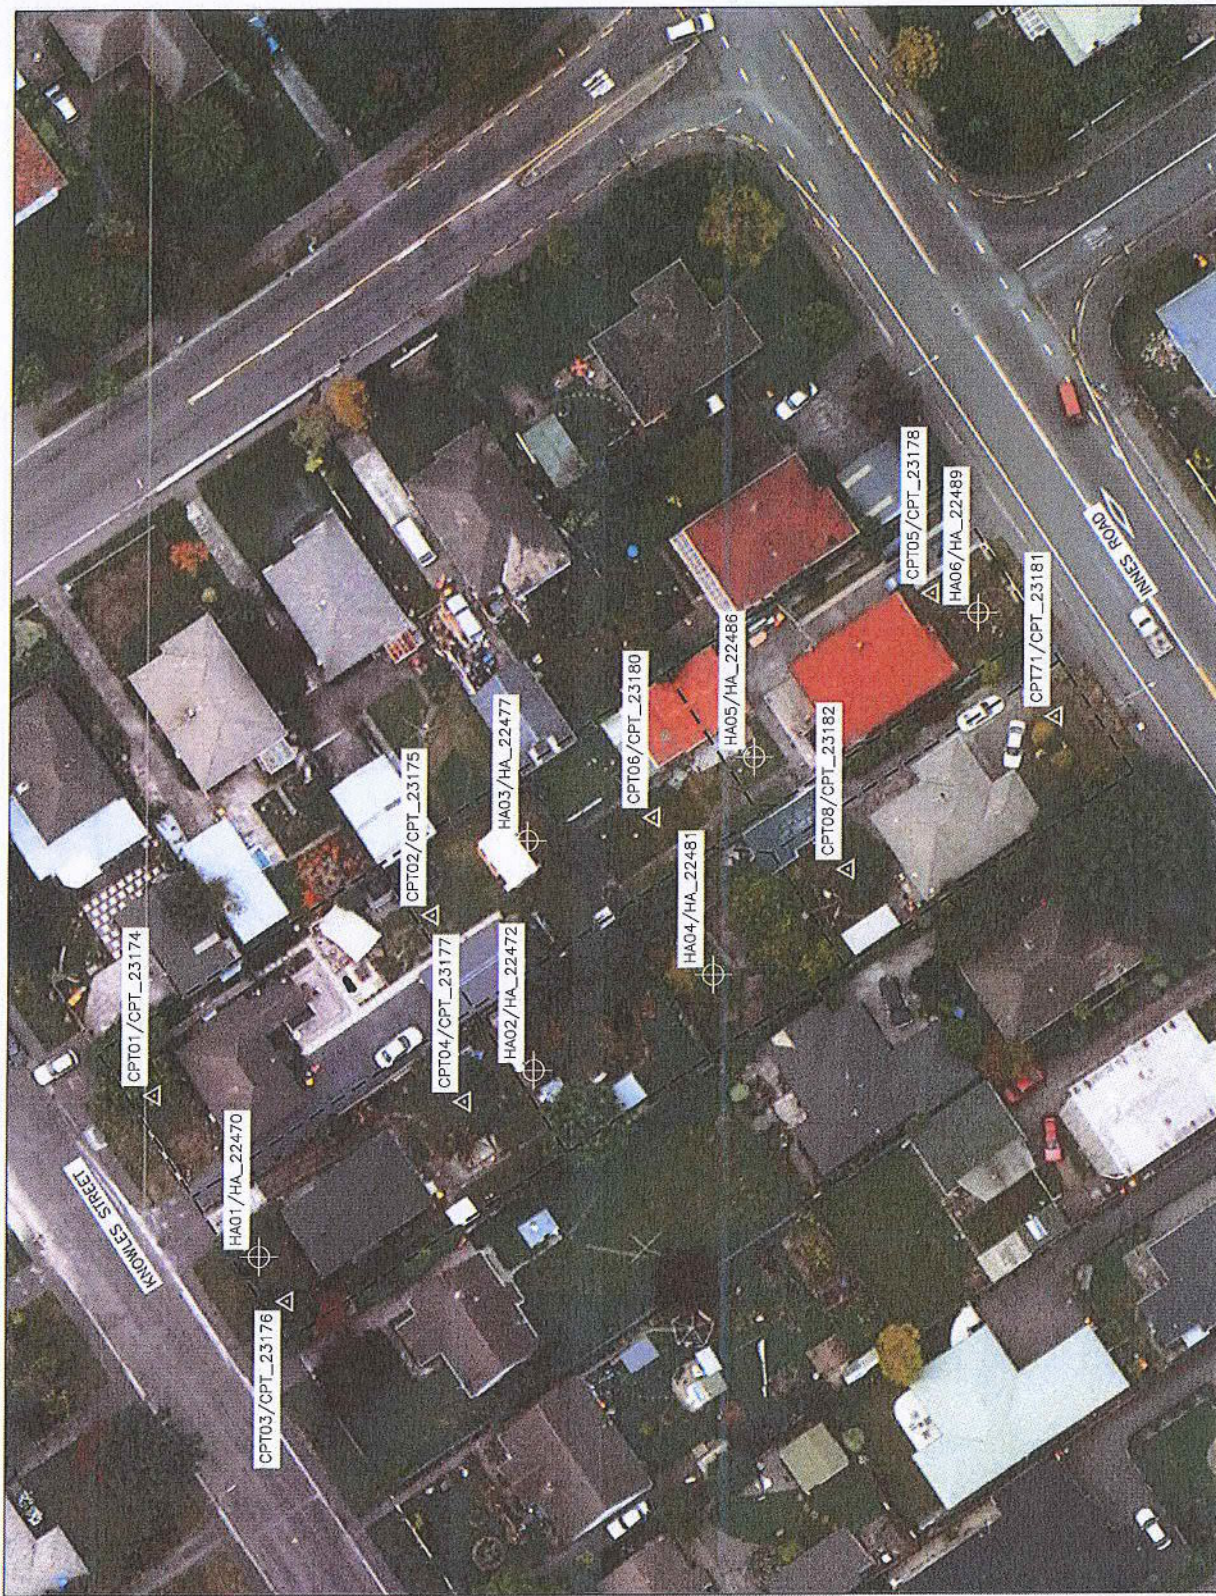
Enc: RILEY Dwg: 14863-1

HAND AUGER HOLE LOCATION  
(CANTERBURY GEOTECHNICAL  
DATABASE)

△ OPT01/OPT\_1  
CONE PENETRATION TEST  
LOCATION (CANTERBURY  
GEOTECHNICAL DATABASE)
