# PROPERTY INSPECTION REPORT

6/200 Papamoa Beach Road, Papamoa

23 September 2026

### **INSPECTION REPORT ADDRESS: 6/200 Papamoa Beach road, Papamoa**

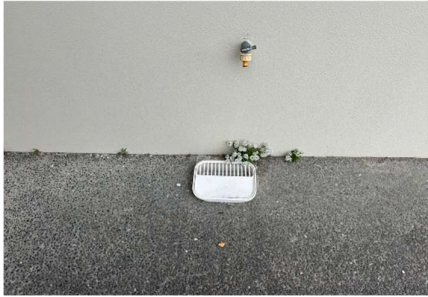
- **Type:** PVC
- **Condition:** Acceptable
- **Gully Trap Height:** Acceptable
- **General:** The top of gully traps must finish no less than 100 MM above unpaved surfaces and 25mm above paved surfaces on the completion of all paving and landscaping. **(NZ Building Code G13/AS2)**

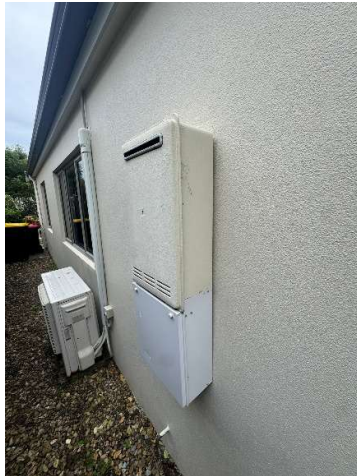
- **Type:** Air Conditioning Unit
- **Condition:** *Marginal - Repairs & Maintenance Required*
- **Noted:** Heavy corrosion is evident to the exterior air-conditioning unit.
- **Recommendation:** *Have the air-conditioning unit assessed by a suitably qualified technician and repair or replace the affected components/unit as required.*
- **Recommendation:** *Clean and service this unit prior to use. Failing to do so can affect insurance cover if heater is found to be the cause of the fire. Heater should be serviced by a qualified technician and client should be supplied with a service certificate.*
