# BUILDING INSPECTION REPORT

9 Sep 2026 / 17 Conie Glen Lane

## Pre-Purchase/Sale Visual Non-Invasive Property Inspection

Eye Spy Property Inspections  
Pre sale building report  
17 Conie Glen Lane, Broomfield

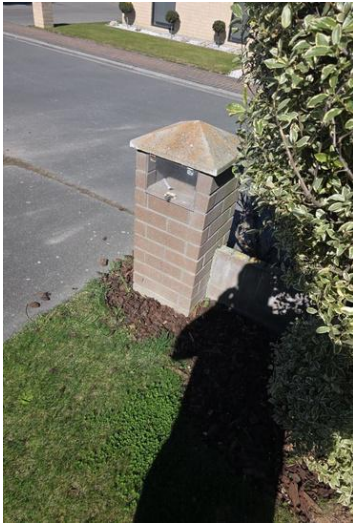
Photo 10

Appears in sound usable condition

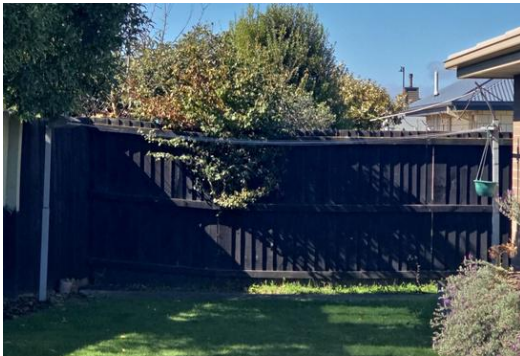
Photo 11

Appears in sound usable condition

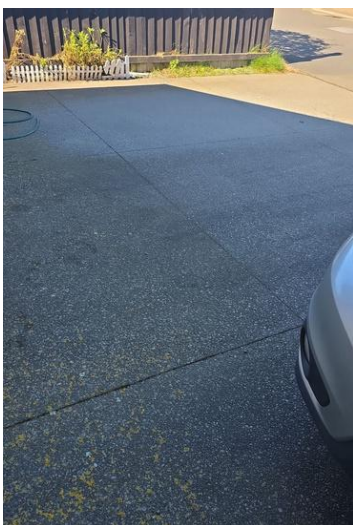
Photo 12

Concrete

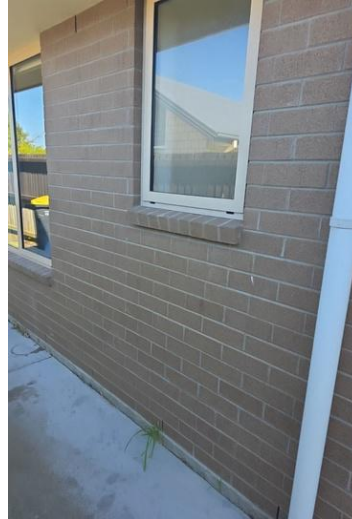
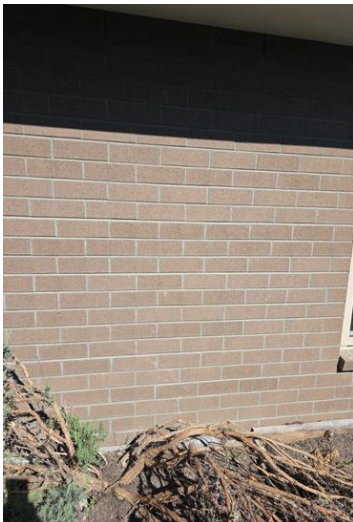
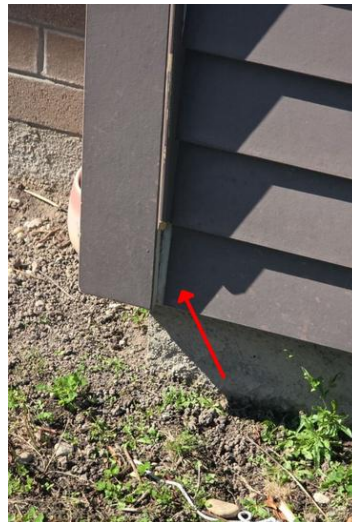
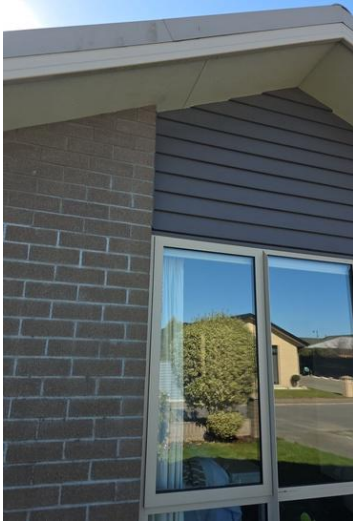
The solid brick veneer on a cavity system appears structurally sound, with no evidence of significant cracking or movement.

The painted linear weatherboard on a cavity system appears to be in a condition typical for its age.

One broken linear scribe has been identified; we recommend engaging a qualified tradesperson for further assessment and remediation.

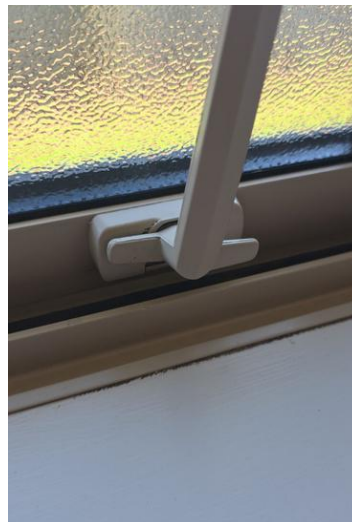
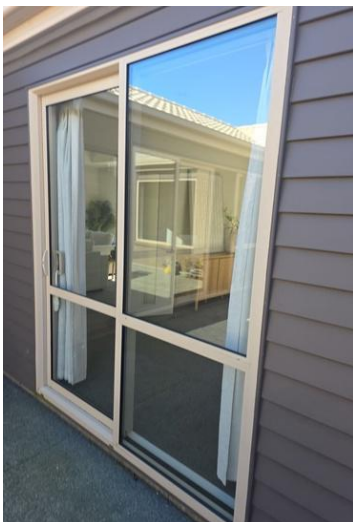
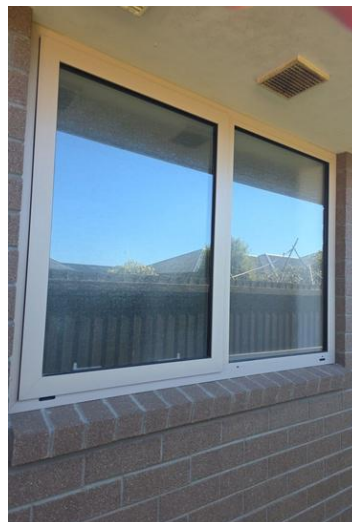
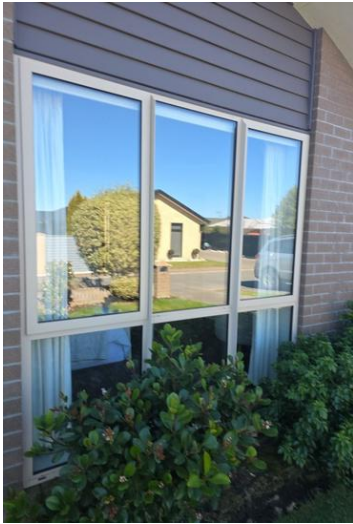
The property features aluminum double-glazed external joinery. Several window catches have damaged closing tabs, which may prevent the units from sealing securely. We recommend engaging a qualified professional to assess the issue and provide appropriate repair solutions.

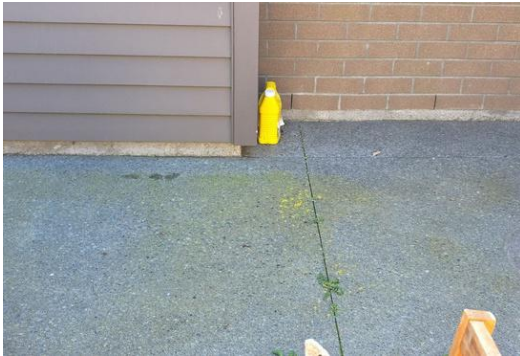
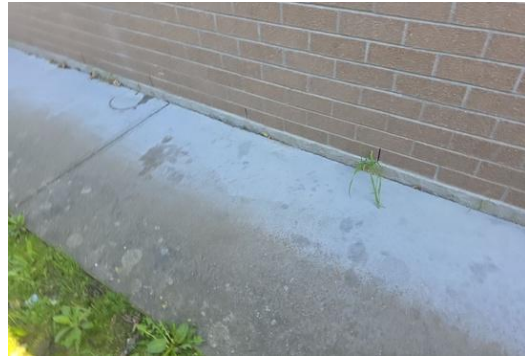
Concrete floor and foundation

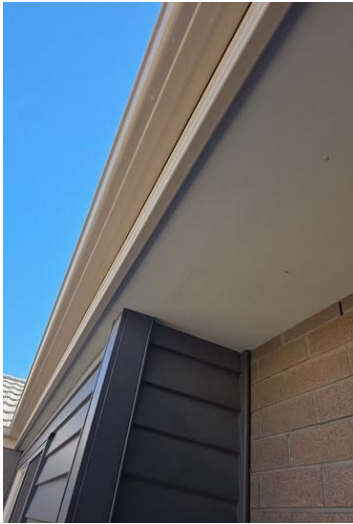
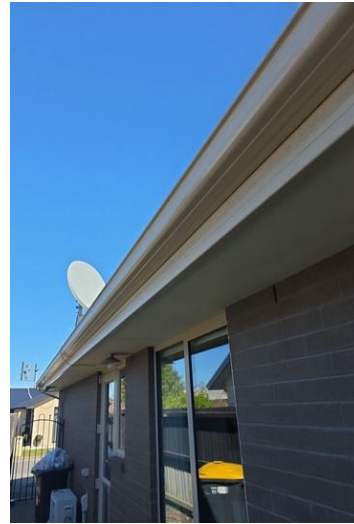
Coil coated steel spouting with painted fibrecement board soffit

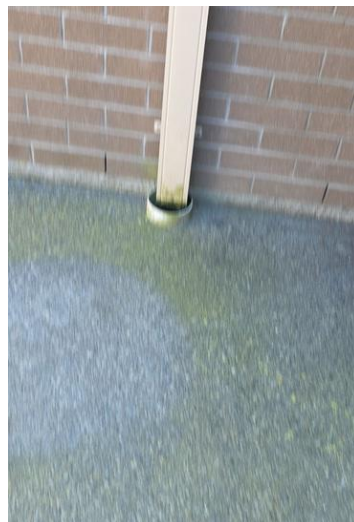
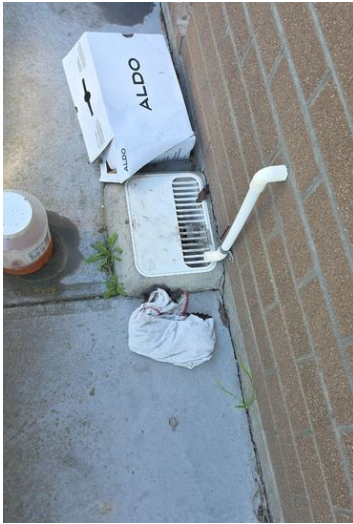
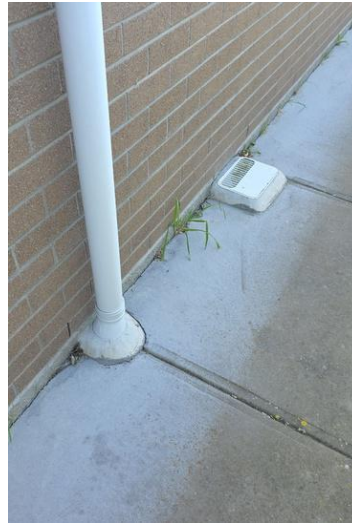
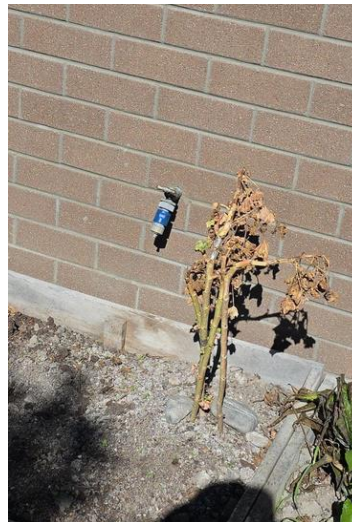
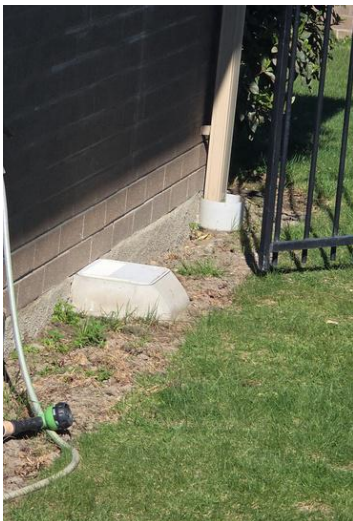
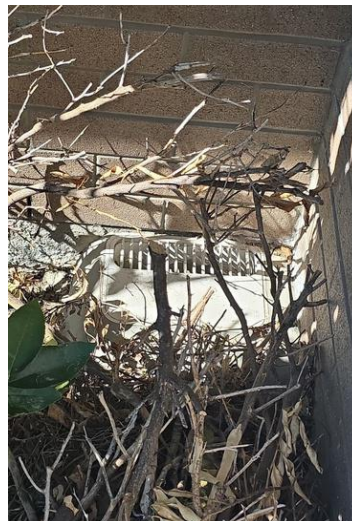
Downpipes fall to pvc stormwater risers. Gully traps clear

No guarantees can be given regarding the integrity of the underground pipes (if any) due to seismic or historical damage and/or blockage.  
Due to the seismic events, it is advisable to have the underground drains CCTV inspected.

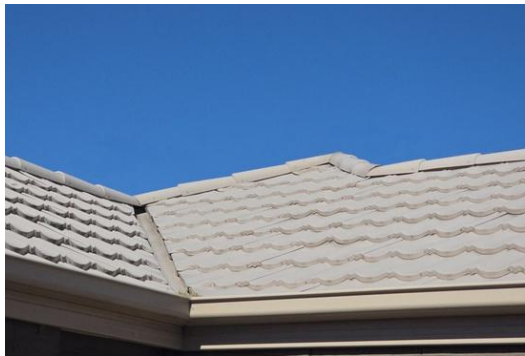
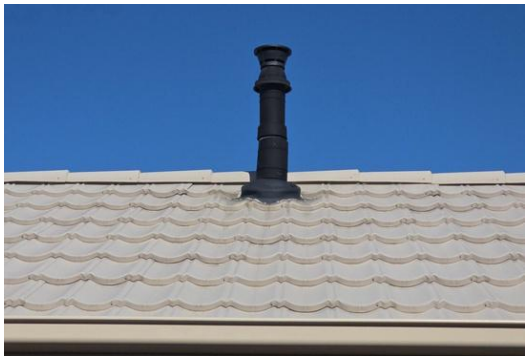
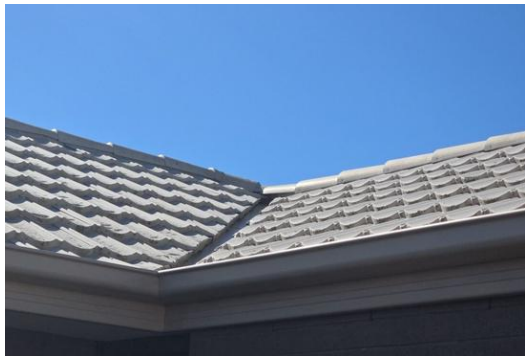
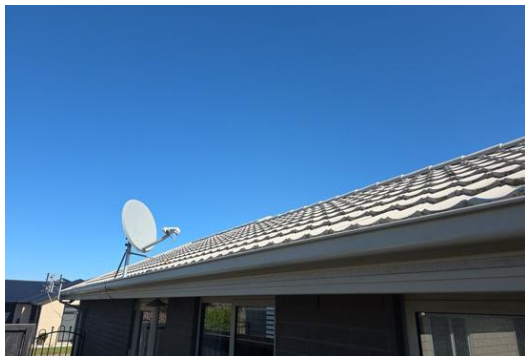
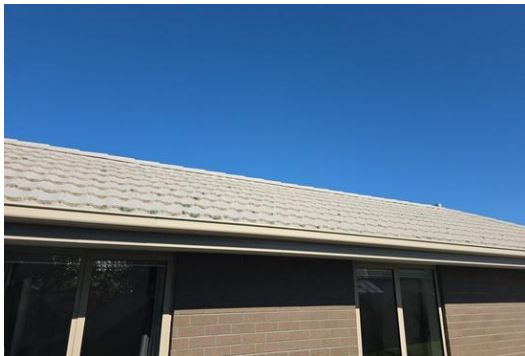
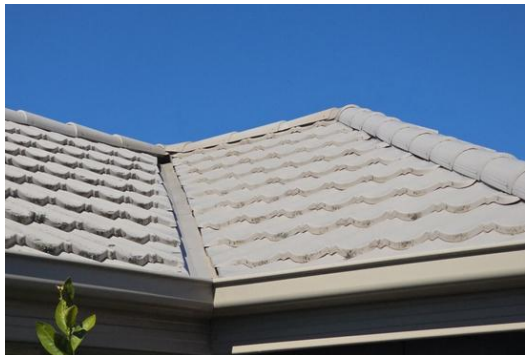
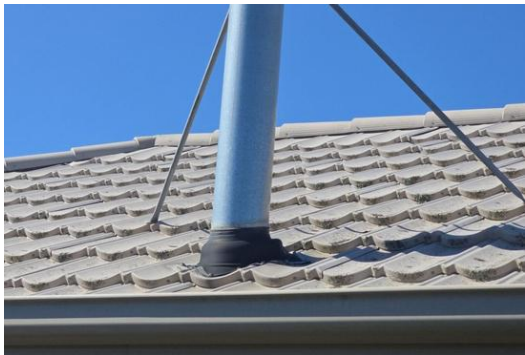
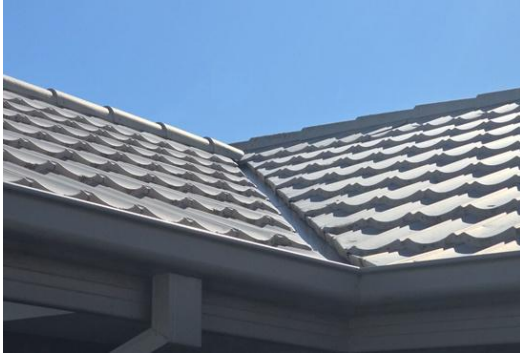
Coil coated steel tiles fixed with galvanized nails appears typical for age

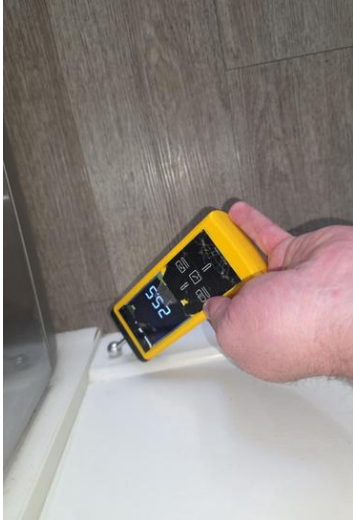
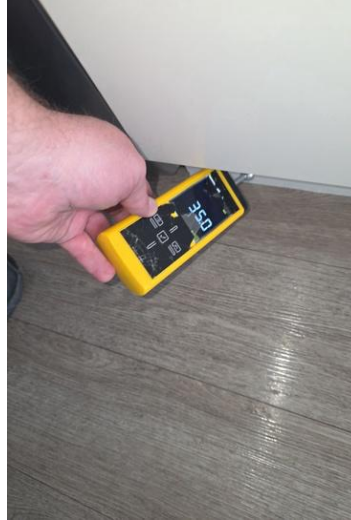
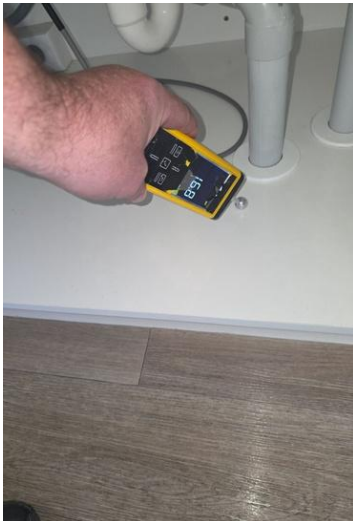
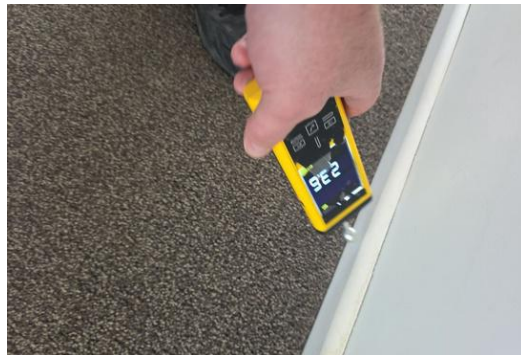
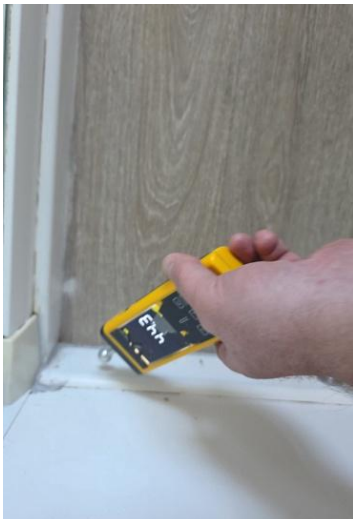
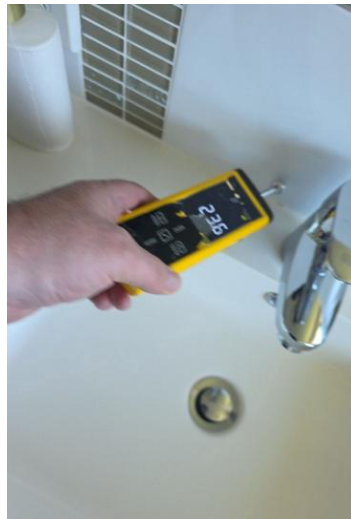
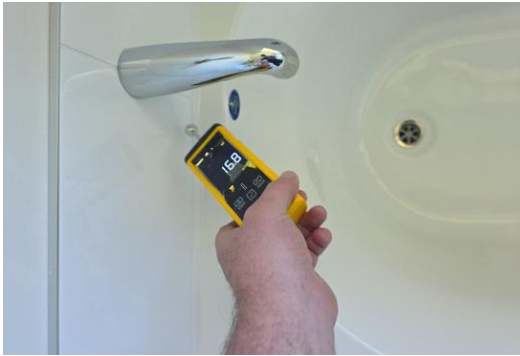
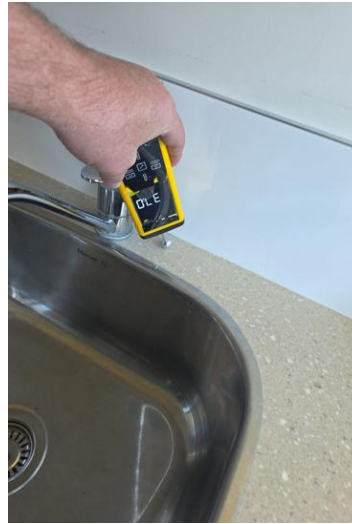
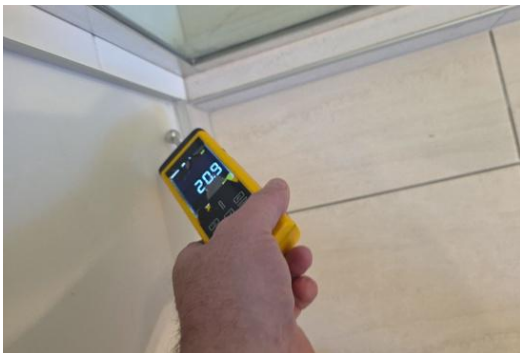
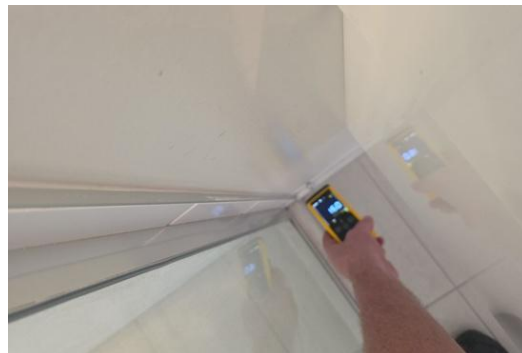
Tested low at the time of the inspection

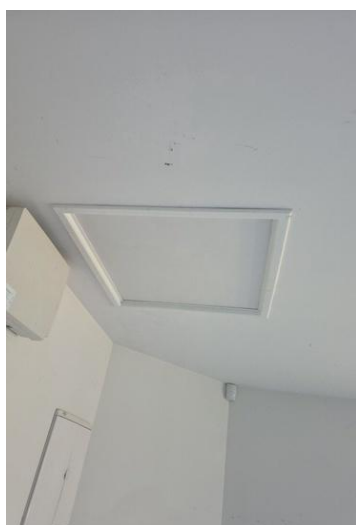
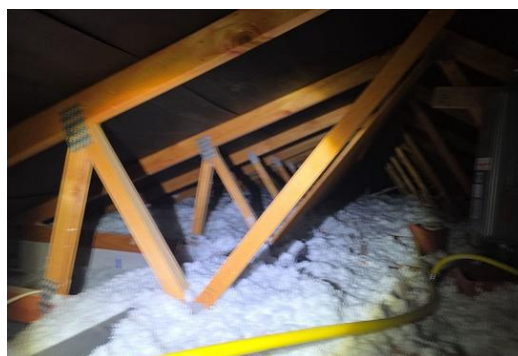
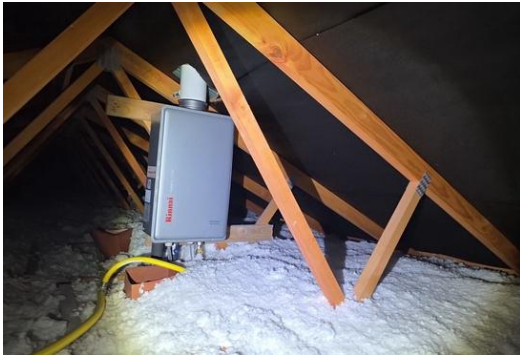
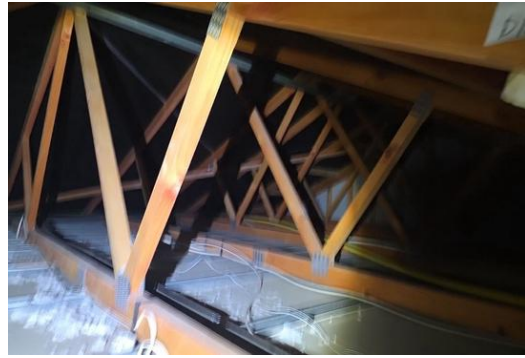
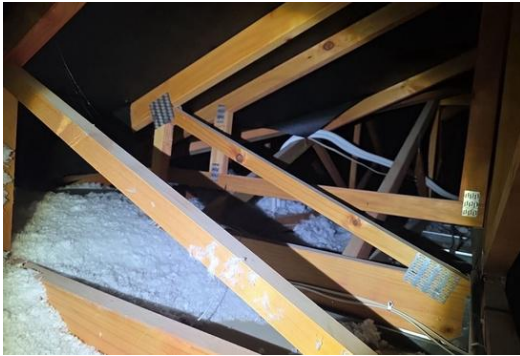
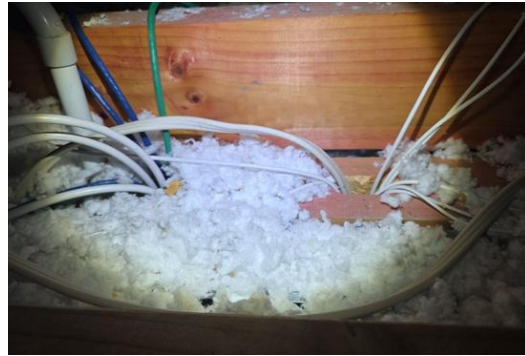
Manufactured timber truss roof

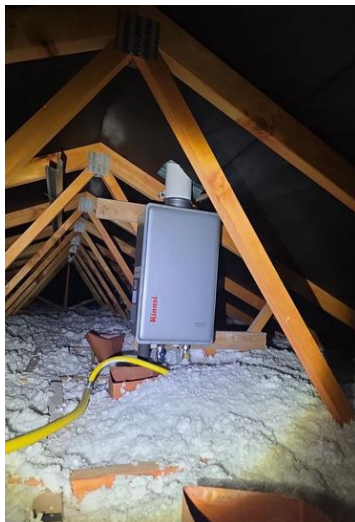
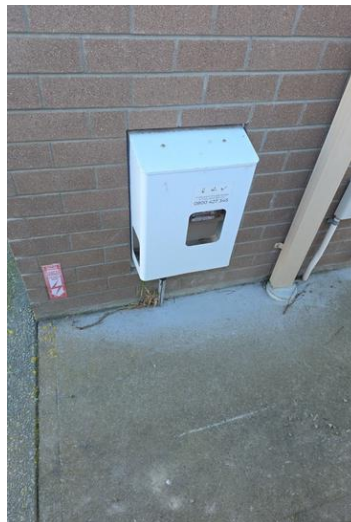
Gas califont in roofspace.  
Street gas supply

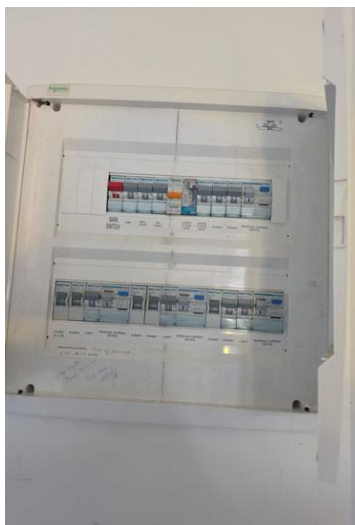
Photo 94

Switchboard in garage has mini circuit breakers. Power was on at the time of the inspection

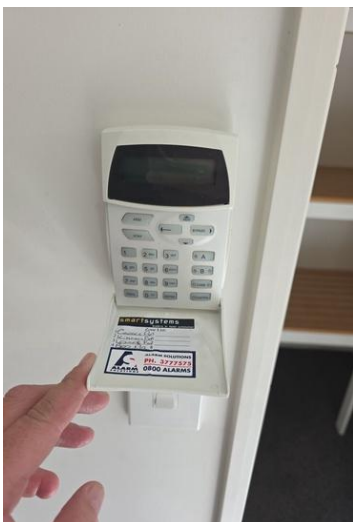
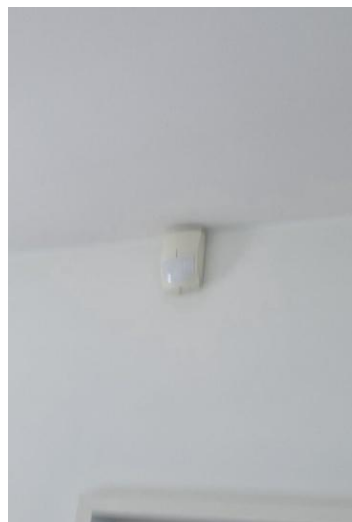
Security system control in entry untested

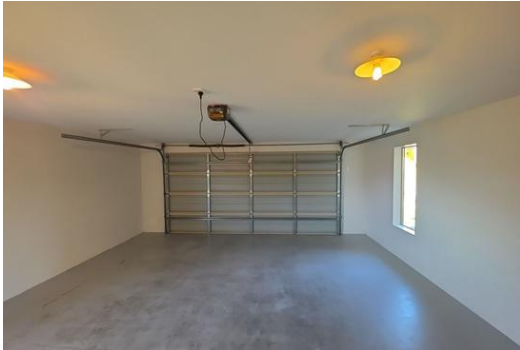
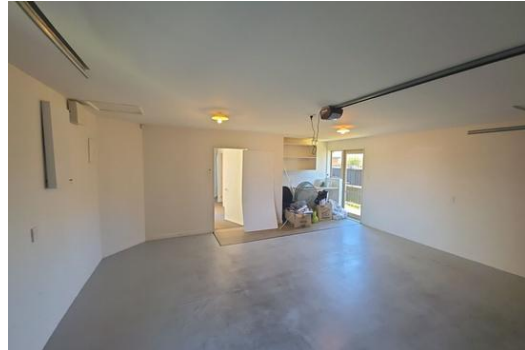
Internal access double garage

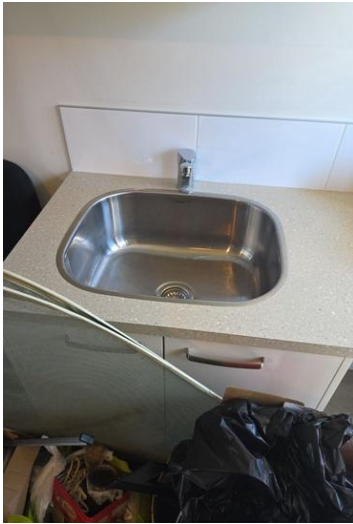
Photo 101

Plumbing fittings appear in sound, usable condition with good hot water pressure, typical for a mains pressure system

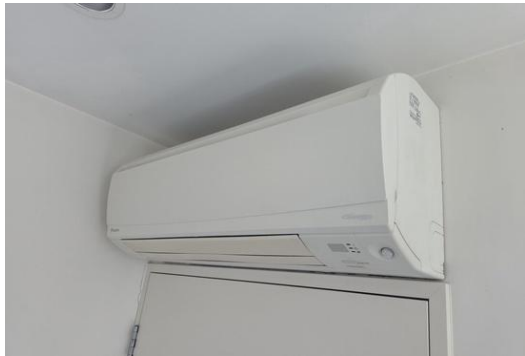
Photo 108

Wall-mounted heat pump appears typical for its age. Untested.

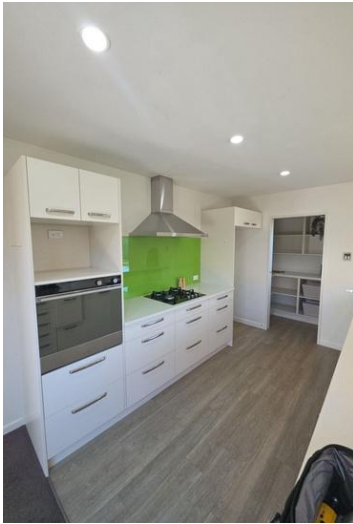
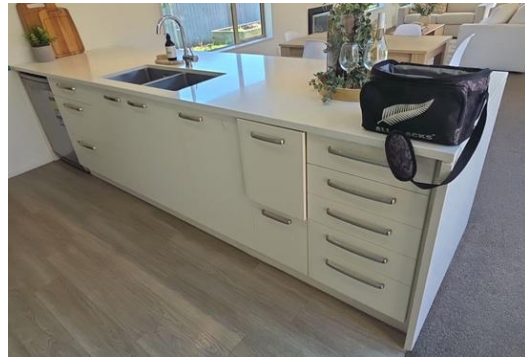
Kitchen joinery appears in sound usable condition

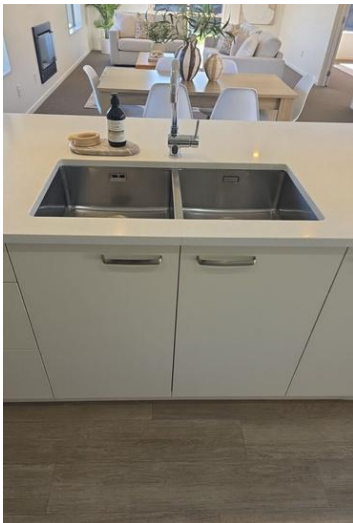
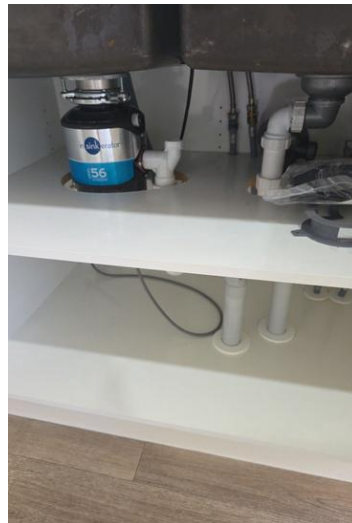
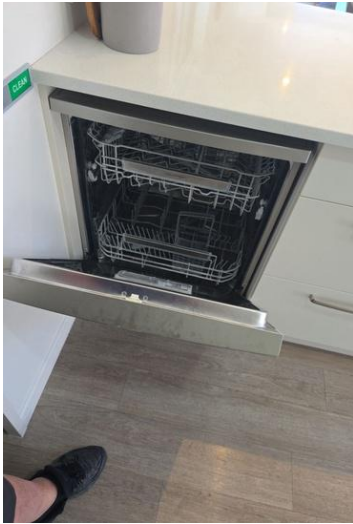
Plumbing fittings appear in sound, usable condition with good hot water pressure, typical for a mains pressure system

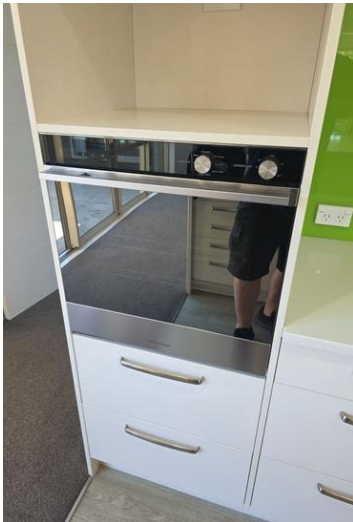
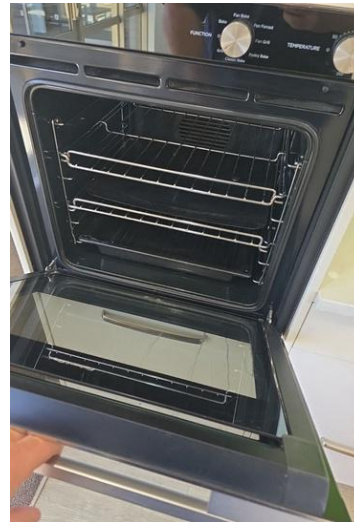
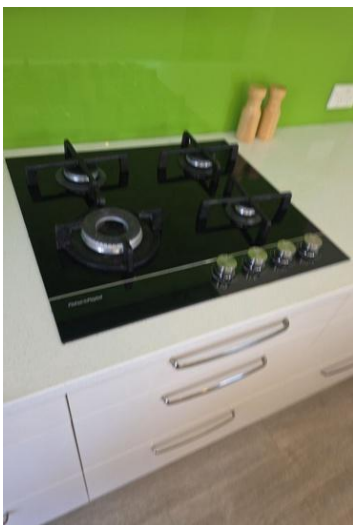
Inbuilt electric oven with gas hob untested

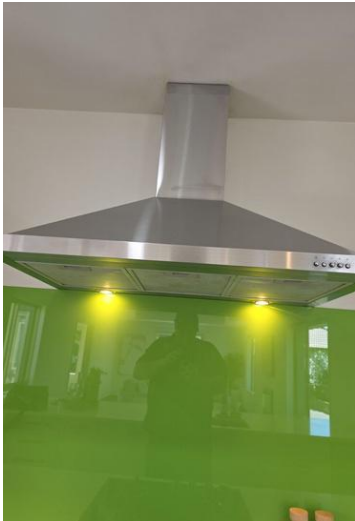
Photo 123

Operational. Externally ducted

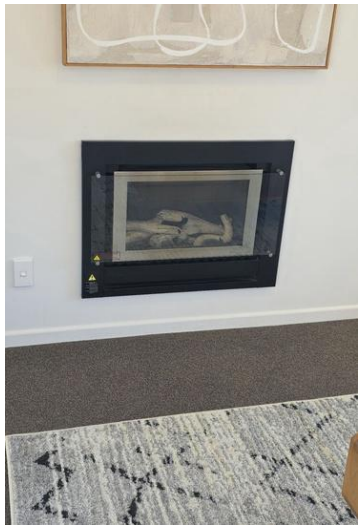
Photo 125

Gas fire untested

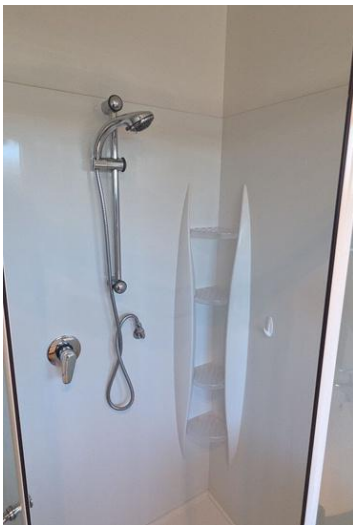
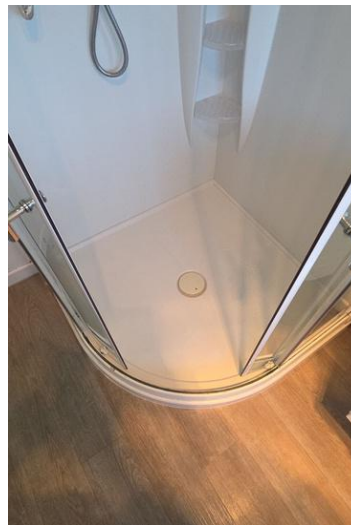
The wet wall liner, situated over the fiberglass base, exhibits characteristics consistent with its age. The shower unit has not undergone testing.

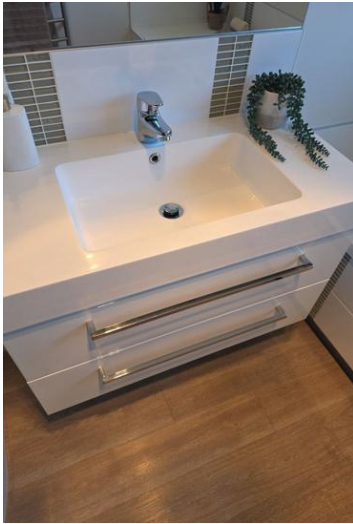
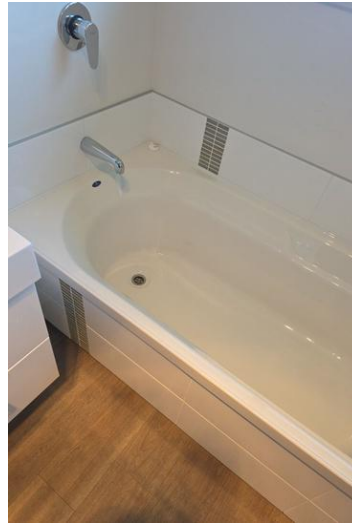
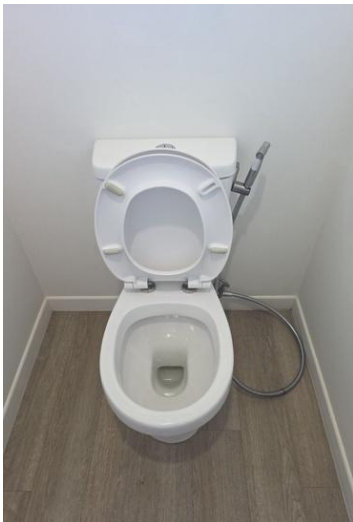
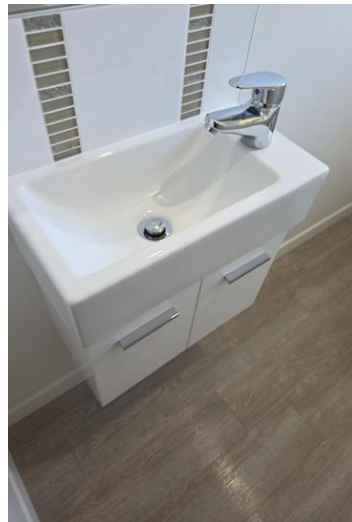
Plumbing fittings appear in sound, usable condition with good hot water pressure, typical for a mains pressure system

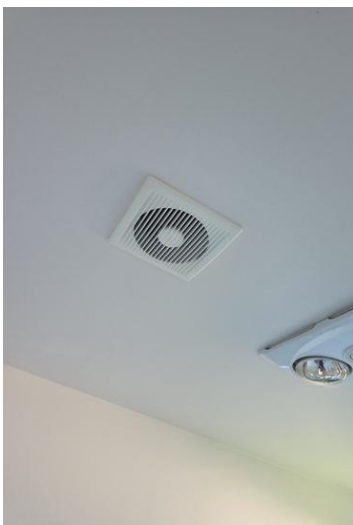
Photo 137

Ceiling fan operational. Externally ducted

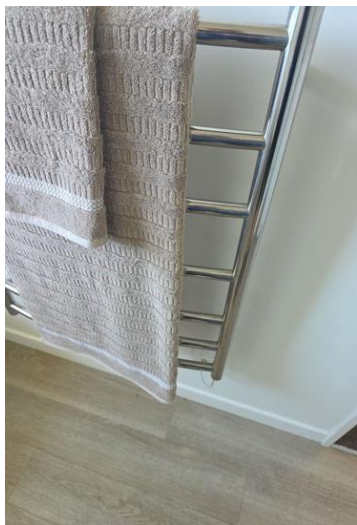
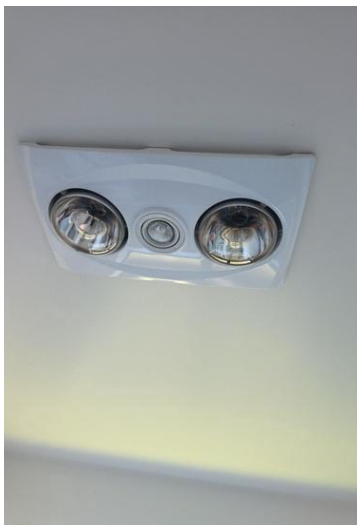
Heated towel rail appears in sound usable condition. Untested.  
Heat bulbs

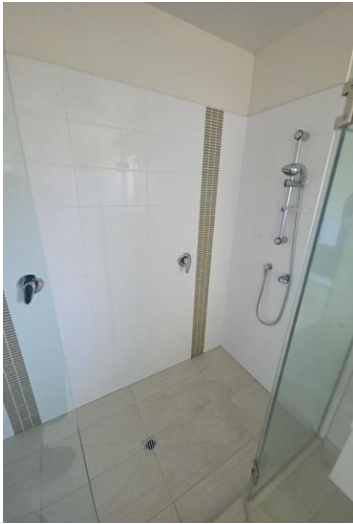
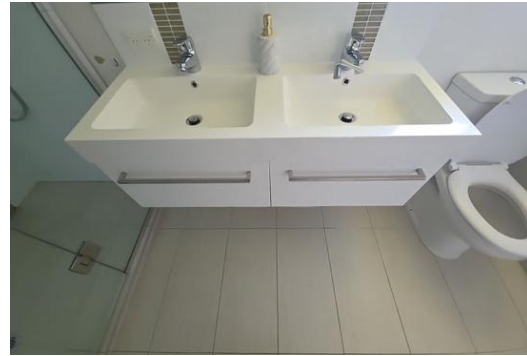
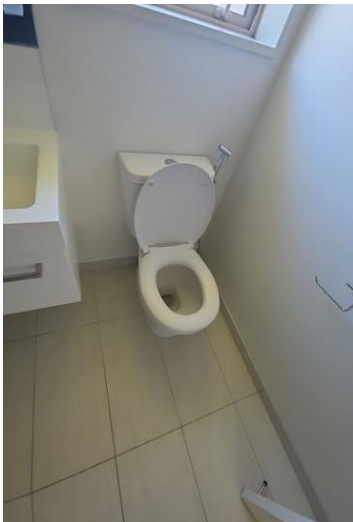
Plumbing fittings appear in sound, usable condition with good hot water pressure, typical for a mains pressure system
